SITE INSPECTION SHEET

ADDRESS: 2868 Glenwood Springs CONTRACTOR: A & S Pools
Glenwood MD 21738 WELL TAG #: HO-81-2744

PROPOSAL: Pool contractor (Anthony & Sylvan) claim
that well location is inaccurately illustrated
in Health Dept. records. LOCATION DIAGRAM

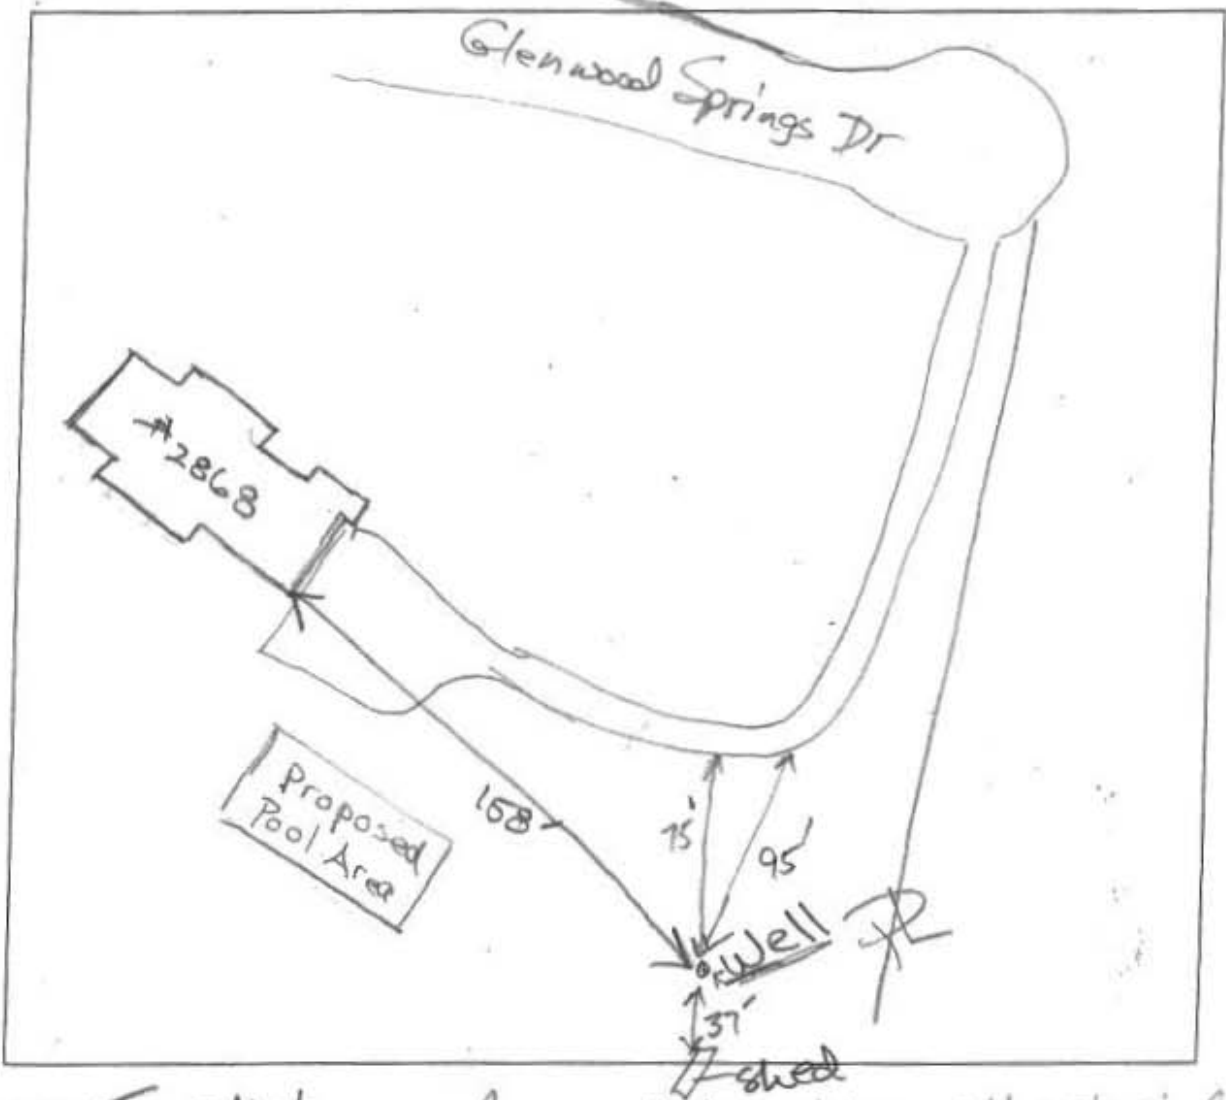
COMMENTS: Tape distances for well location illustrated.
Steel casing to 8" above grade, 1-pc metal cap broken,
electrical wiring exposed.
