RECEIPT DATE: 5/22/2024 **ONSITE SEWAGE DISPOSAL SYSTEM** P 586690

APPROVAL DATE: 5/31/2024 **PERMIT: REPAIR** A _____

PROPERTY ADDRESS: 7600 Pindell School Road

Date: April 8, 2024 Name of Evaluator: Mitchel Ruhkamp Time: 9:00 AM Property Address: 7600 Pindell School Road Fulton, MD 20759 Recent Weather Conditions: Fair	Ordered By: Todd Werling Buyers: Scott Cameron Homeowner Interview: The homeowner interview was sent but not received prior to the evaluation.	Occupied: <input type="checkbox"/> Yes <input checked="" type="checkbox"/> No Length of Time Vacant: Unknown # of People Living in Home: N/A # of People moving in: 3 Property Age: 1974 System Age: Unknown Last Date of Cleaning: Unknown Recomm'd Pumping Freq: 2-3 Years
---	---	---

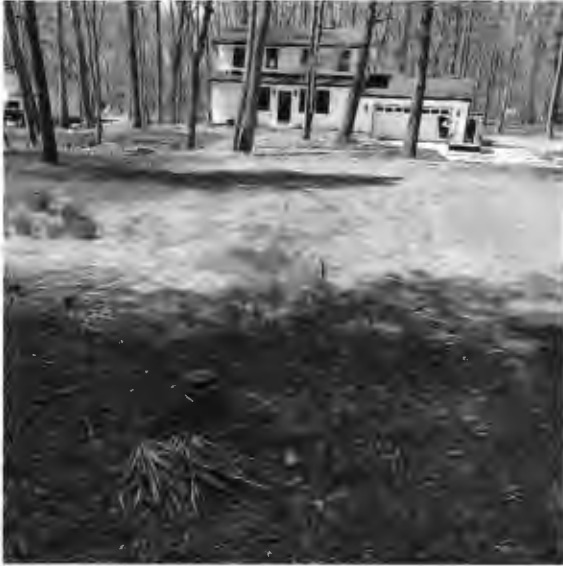
Picture 1:

This shows the septic tank in relation to the house.

System Component	Condition	Comments
Septic Tank	<input type="checkbox"/> Acceptable <input checked="" type="checkbox"/> Unacceptable <input type="checkbox"/> Needs Further Evaluation	The septic tank is composed of concrete and is approximately 750 gallons in total capacity. The septic tank is 30 inches below grade and is accessible via a cast iron cleanout at grade. It is recommended a manhole riser be installed to grade to facilitate future maintenance. The front baffle and back baffle are both in place and both are composed of terracotta. Currently, there are 5 inches of solids in the septic tank. The septic tank should be cleaned in the next 2 years and every 2-3 years after. A root intrusion was observed in the septic tank. The root intrusion will need to be remediated by a licensed septic contractor. A camera was used as part of the inspection. During the camera inspection several bellies and an obstruction were encountered in the front line. The front line will need to be remediated by a licensed septic contractor. Remediation may include replacing the front line. The laundry plumbing appears to exit the side of the house through a separate 2" pipe to a unknown location. The laundry plumbing will need to be tied into the septic tank by a licensed contractor. Please refer to page 2 and the camera septic report for further information.

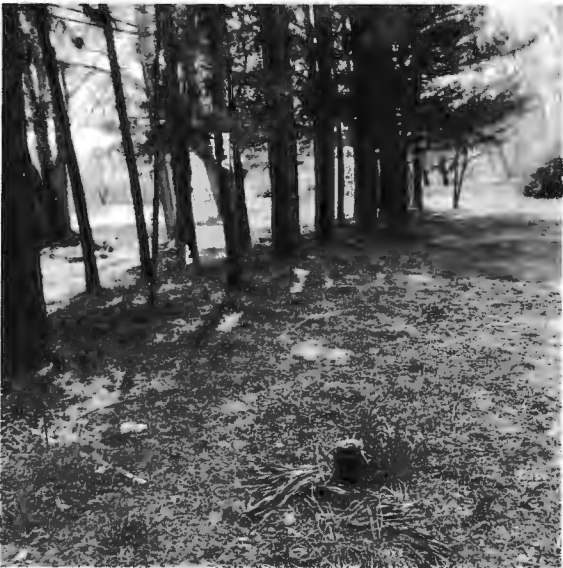
Picture 2:

This shows the septic tank in relation to the tree line and road.

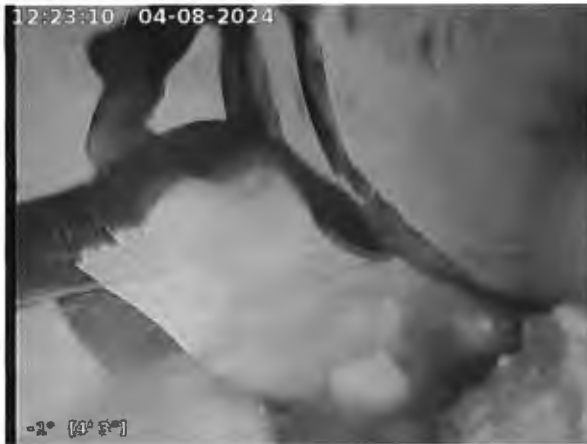
4' 3"

Turn in line.

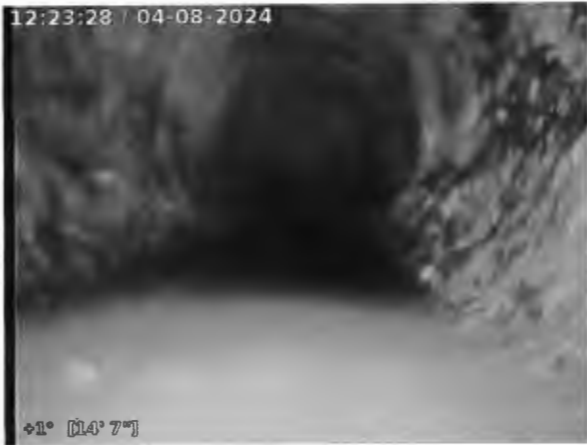
14' 7"

End of belly.

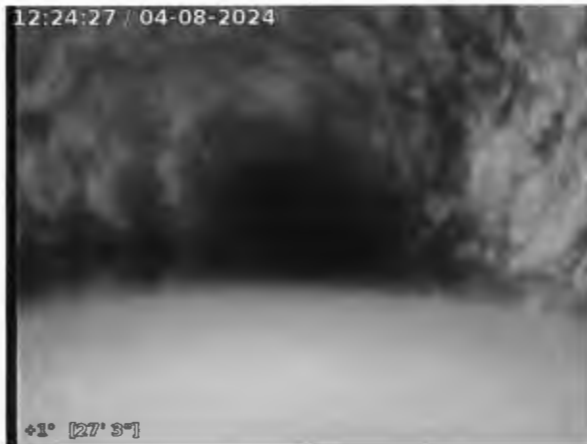
27' 3"

Start of second belly.

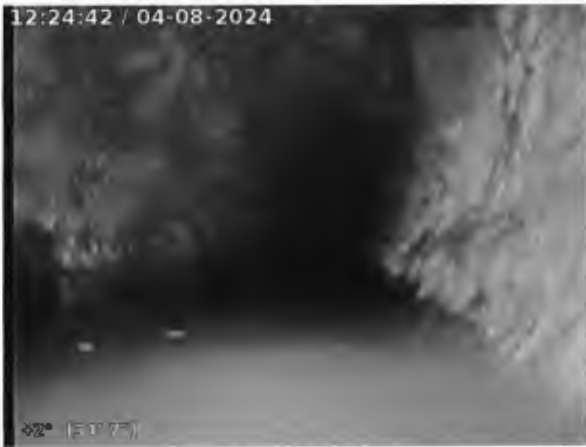
34' 7"

End of second belly.

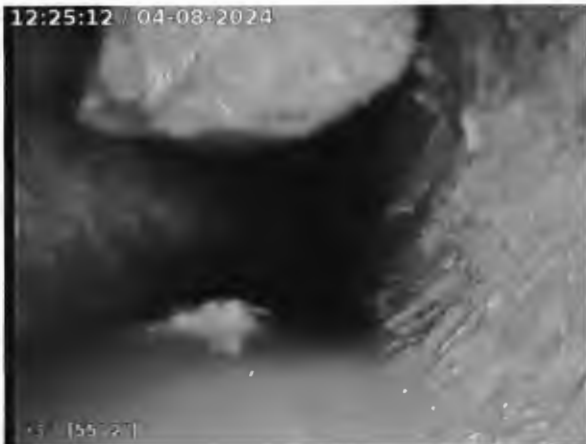
55' 2"

Junction with cast iron snakeline next to the driveway.

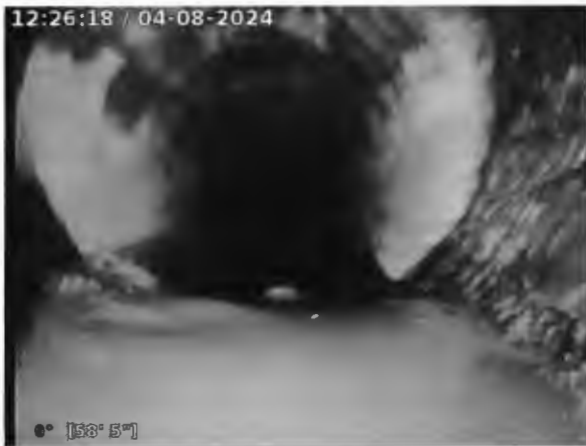
58' 5"

Transition back to PVC and start of third belly.
